**Flood Control Project Maintenance
Levee Inspections**
LMA District Cover Sheet
Spring 2018 Levee Inspection Results

Solano County Public Works Mellin Levee

Levee Inspection Report By Mile - Spring 2018

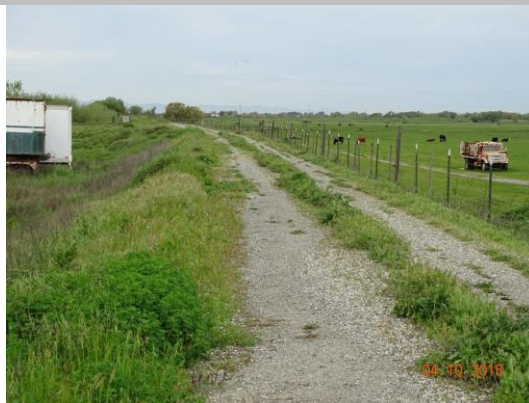
Photo 1 of 1 : SP_2018_NA0012_258_1_20180410_00008.jpg

| LM Start | 0.00 | Rating ** | U | Issue No. | 1 |
| Item | Vegetation | | | 38.174055 ° | 38.176849 ° |
| V1 : Control annual grass and weeds on the levee slopes and easements. | | | | | |
| Unable to adequately see landside due to vegetation. | | | | | |

Landside vegetation should be managed to allow inspection of ground surface and access.

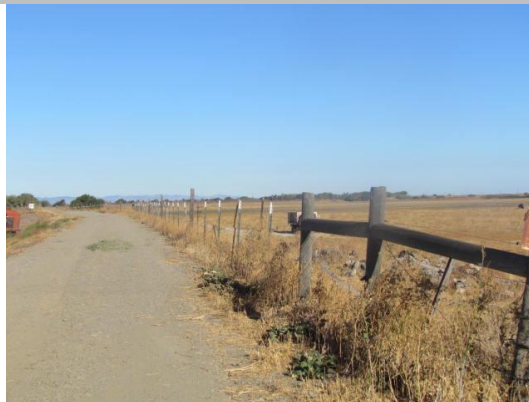
Photo 1 of 1 : SP_2018_NA0012_258_3_20180305_00003.jpg

| LM Start | 0.01 | Rating ** | M | Issue No. | 3 |
| Item | Encroachments | | | 38.174167 ° | 38.180084 ° |
| FE : Fence | | | | | |

Looking west at fence on waterside shoulder.

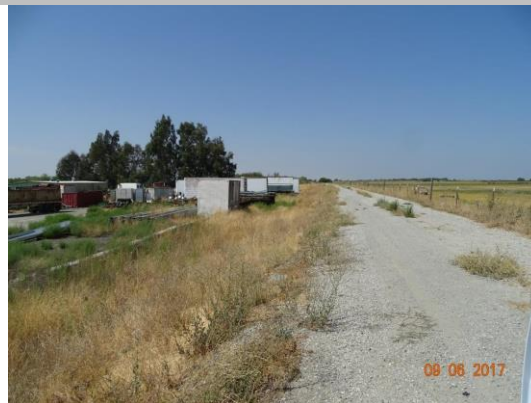
Photo 1 of 1 : SP_2018_NA0012_258_8_20180305_00007.jpg

| LM Start | 0.03 | Rating ** | M | Issue No. | 8 |
| Item | Encroachments | | | 38.174356 ° | 38.174834 ° |
| EQ : Equipment | | | | | |
| Tractor trailers and equipment at landside toe. | | | | | |

Looking northwest at the equipment on the landside toe.

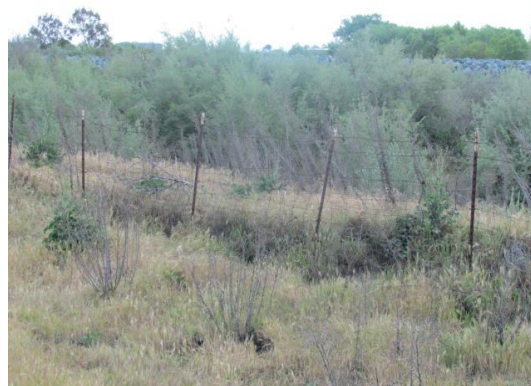
Photo 1 of 1 : SP_2018_NA0012_258_4_20180305_00004.jpg

| LM Start | 0.10 | Rating ** | M | Issue No. | 4 |
| Item | Encroachments | | | 38.175115 ° | 38.176805 ° |
| FE : Fence | | | | | |

Looking southeast at fence on landward slope.

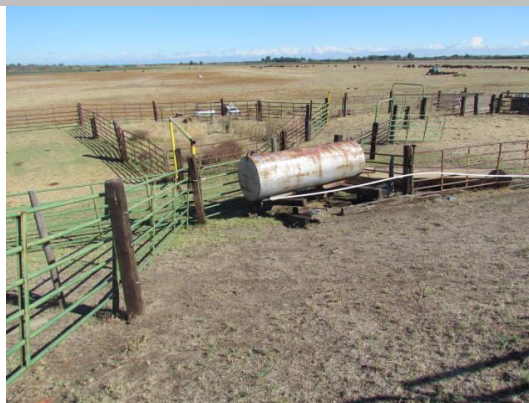
Photo 1 of 1 : SP_2018_NA0012_258_2_20180305_00002.jpg

| LM Start | 0.58 | Rating ** | M | Issue No. | 2 |
| Item | Encroachments | | | 38.179951 ° | 38.179951 ° |
| TA : Tank | | | | | |
| Water tank and fencing on waterward shoulder and slope. | | | | | |

Looking north at water tank stored at waterward toe.
